Grenzebach helped USG reopen its plant after an earthquake, saving millions

Tecomán,
Colima in Mexico

Repaired and optimized damaged Grenzebach board dryer

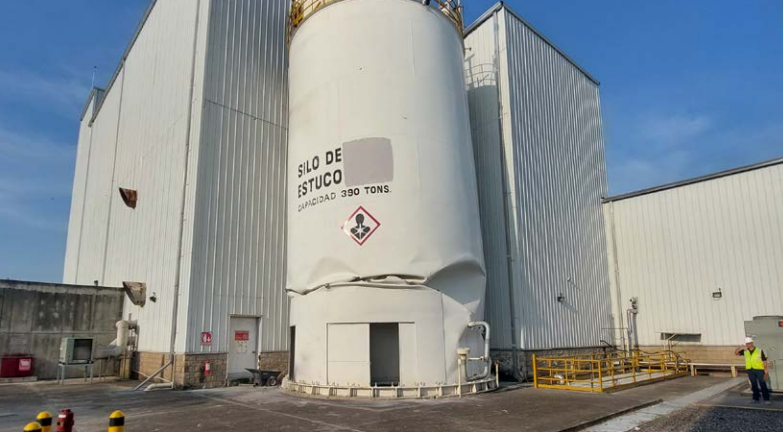
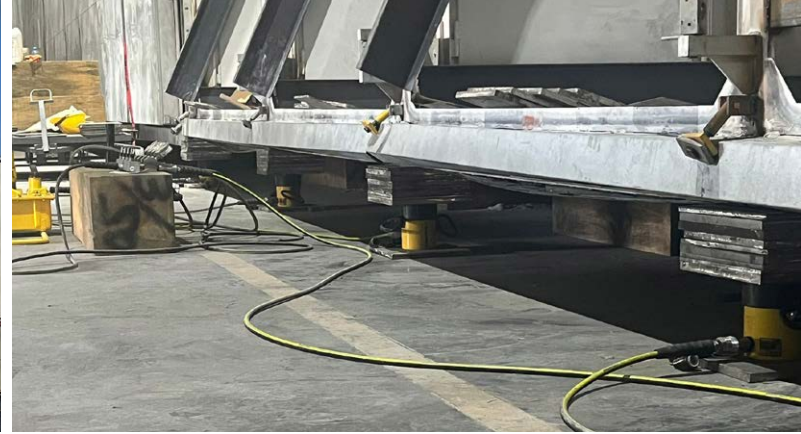
But the Grenzebach dryer had been shaken completely off its rail system. With very little room overhead, the five-segment dryer would need to be lifted high enough to repair the damaged attachment points and re-align the rails. The 390-ton gypsum silo had also collapsed.

The board dryer comprises five segments. These segments normally mount onto rails that allow the oven to extend in length as it heats up. The earthquake caused two of these segments to completely leave their rails. The tracks beneath the other segments had shifted.

To execute the repairs, all segments had to be lifted. Each one weighs 120 tons. The derailed segments only required a lift of 100 - 200 mm. Workers needed to physically access

the area beneath the shifted segments, however. This required a lift of at least 750 mm. There was only 800 mm of space between the ceiling of the production hall and the top of the dryer. And without a silo, production would need to somehow be synchronized.

ed electrical power lines, and capped the gas lines. The team then used hydraulic lifts to elevate the segments enough to repair the attachment points and realign the tracks.

In the process of these extensive repairs, Grenzebach also examined the airflow in the dryer. Adjustments minimized the amount of unsaturated exhaust air leaving the dryer and lowered humidity on the dryer floors. These optimizations have reduced gas consumption by 10 % and electrical power consumption by 40 %.
